Valeriy Migunov,
test pilot and flight instructor
("Antonov" state enterprise, Kyiv, Ukraine)

Determining the angle of attack as a critical element of flight

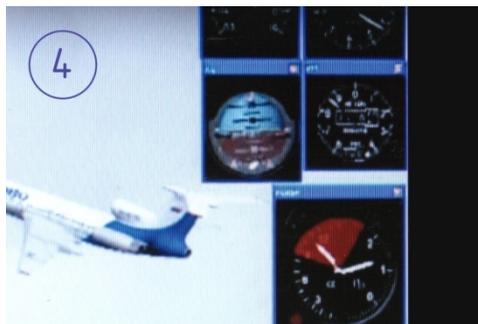
Fig. 1. Flight instrument indications of Tu-154 during the Donetsk tragedy

A thorough analysis of the Donetsk tragedy (see Figure 1) makes it clear due to the records available in the Internet. The crew decided to bypass the high clouds by requesting the transcendental flight level 390 (the outside air temperature was above the standard by 20°C). The analysis was made over the last 5 minutes of flight, 2 minutes 37 seconds of which the plane was in a spin.

All operators must firmly understand that the pitch angle read from the air horizon has nothing to do, in common sense, with the angle of attack, at a pitch of $\pm 90^\circ$, the angle of attack is 0° , and with a flat normal spin (Donetsk tragedy – TU-154), the pitch is $10-20^\circ$, and the angle of attack reaches 90° , and to understand that

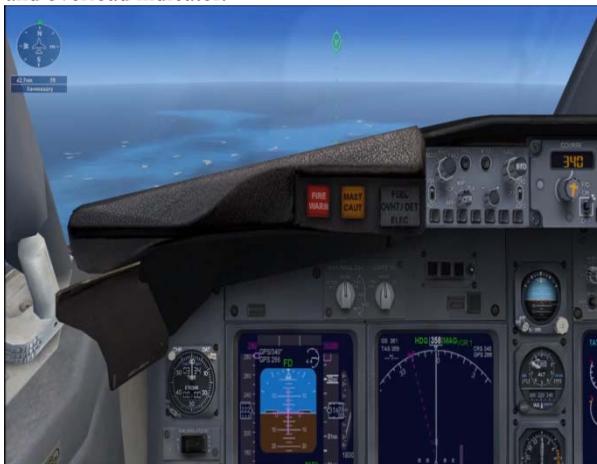
Fig. 2. Attack angle indicators in the cockpit of Boeing 737

Another reason to think about the need for the attack angle indicators in the cockpit was the very similar air crash that occurred in 2013 with Boeing 737-400 (see Figure 2) in Kazan and in 2016 with Boeing 737-800 in Rostov-on-Don. After these shocking tragedies, I simulated similar situations on the An-124-100 simulator. The purpose of the experiments was to determine the safe transition of an airplane
